# Above The Falls: Natural Areas Scoping

Friends of the Mississippi River  
360 North Robert Street, Suite 400  
St. Paul, MN 55101  
Ph: 651-222-2193 x33  
December, 2012

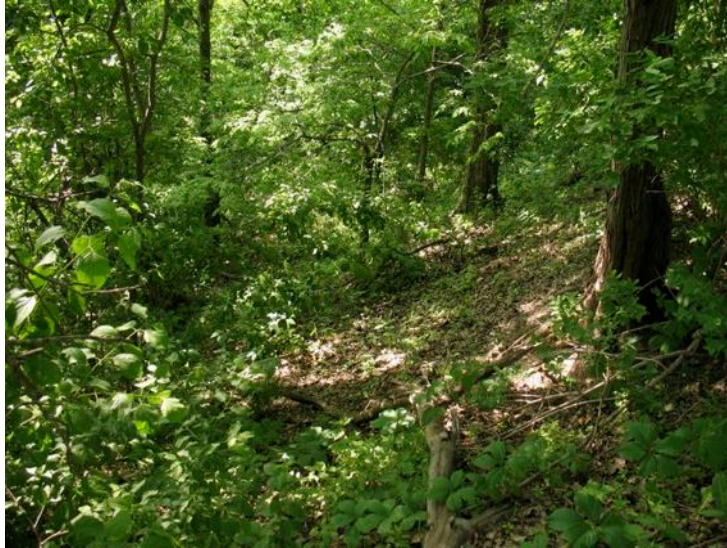
This area was significant in that it appeared to still have had the landscape shape and contours of its pre-settlement condition, without appearing to have been too severely altered (Photo 1). The soils had not been altered, at least not obviously. It

Photo 1. Broad river buffer at St. Anthony Pkwy.

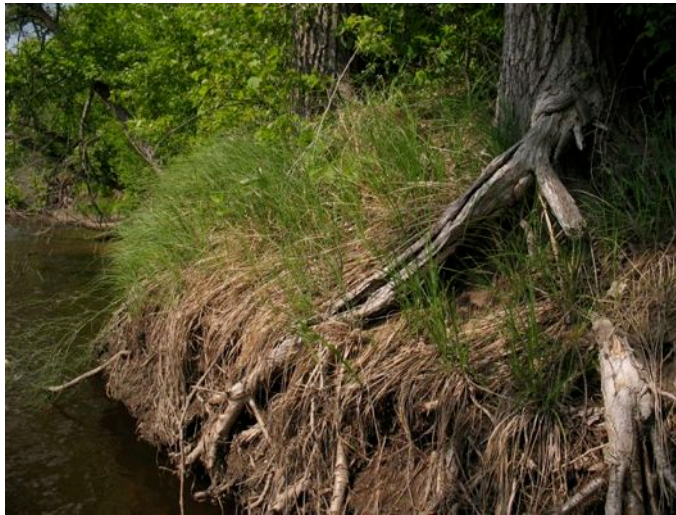
Photo 2. Cottonwood clinging to bank provides a refuge for a native plant community on this bank.

clinging on the lower banks (Photo 2). A few root wads were also left holding, too. Gathered around each root wad or cottonwood tree were remnant communities consisting of a few natives: prairie cord grass, sedges (short sp.), geranium, dogbane, milkweed, poison ivy, goldenrod, Solomon's seal, stonecrop, wild rye, etc. Where the sedges occurred, the undercut toe formed a ledge, due to the fibrous roots of the plants—beneficial for fish habitat. Otherwise, the

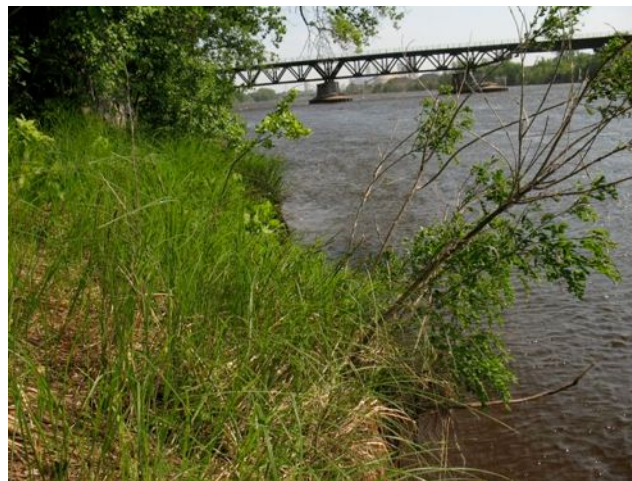
bank was eroding fast. Prairie cordgrass patches seemed to provide the best protection from erosion—there was less “erosion front” where prairie cordgrass patches were present (Photo 3).

Photo 3. Prairie cordgrass, native sedges, and false indigo bush provide stability to the bank near the base of a large cottonwood tree.

**RECOMMENDATION:** We recommend removing buckthorn, honeysuckle, and caragana shrubs. Look for the fallen cottonwood/root wad that protrudes into water. And look for last pullout before Camden Bridge—down from there, by the big cottonwoods—just north of the benches—that is where the best communities exist. There was abundant poison ivy, so take care

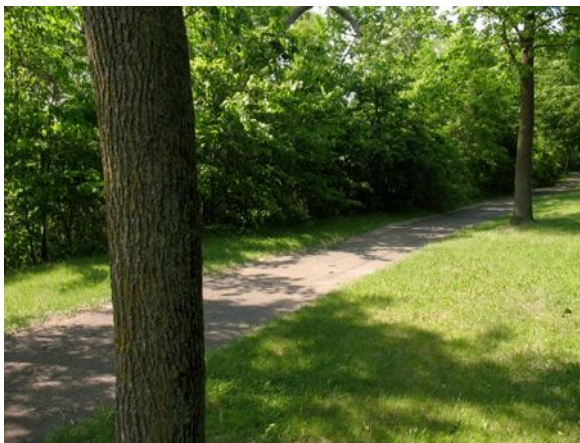
Photo 4. Mississippi River Park, just south of the Soo Line RR Bridge. Note the abundant Tartarian honeysuckle shrubs.

**RECOMMENDATION:** This park could be reconstructed, but should be a lower priority. We would advise to do this only if the St. Anthony Parkway stretch, north of the Soo Line RR Bridge, were restored first.

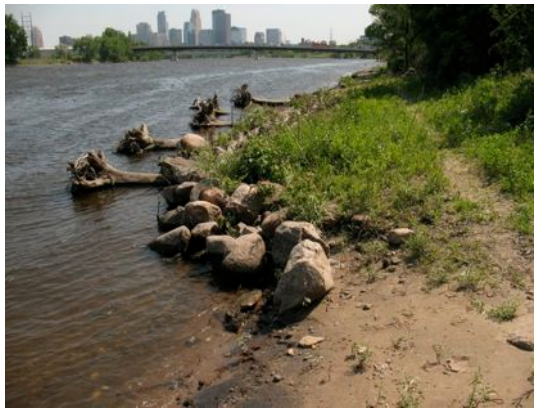
Photo 8. Root wads installed previously on shoreline. Compare the green vegetation behind the protection with the brown bare soil in front of it.

These root wads appear to be working—they are still intact, and behind them were a few native plants (sand bar willow, milkweeds, etc.) that were surviving. Based on the success of this practice, we recommend installing more root wads along the shoreline here and perhaps throughout the entire Above the Falls zone.

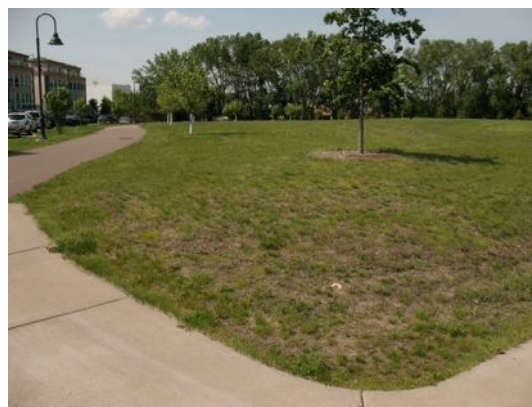
Photo 9. Flat “parkland” area on upland near road. This area could readily be reconstructed to native prairie.

**RECOMMENDATION:** We recommend that this area be reconstructed to a mixed short-/long-grass prairie. South of the street was a large condominium development. Perhaps the residents could be engaged to become stewards of this park?

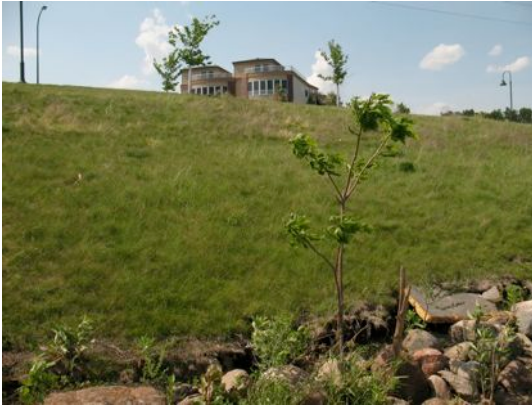
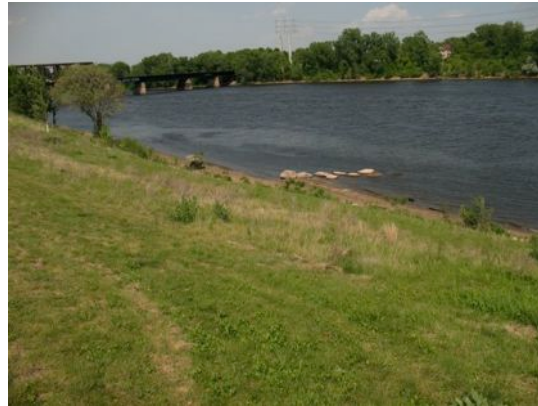
Photo 10. Short grass slope on upper bank. Note the condominiums in the background of the photo, at the top of the slope.

Photo 11. Newly vegetated slope. This could readily be restored to native prairie.

The area on the bank, to the south, between Ole Olson Park and the 22<sup>nd</sup> Ave Raingarden, was basically an open, grassy field (Photo 10, 11). It appeared that a prairie restoration was attempted here (a few little bluestems persist), but the area was dominated by non-natives including fescue, bluegrass, and gumweed. It is

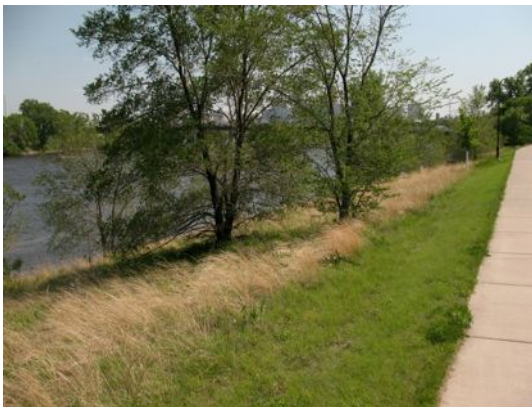
Photo 12. Riverbank across sidewalk from 22<sup>nd</sup> Ave Raingarden. Note the many Siberian elm trees—they serve as a prolific seed source that contaminates the surrounding landscape.

though (Photo 12). It needs to be burned!

**RECOMMENDATION:** Remove Siberian elms, spot-treat herbaceous weeds, burn, and seed with native prairie species. Basically, restore in the same manner as the adjacent bank to the south, which is across from the raingarden. Continue to burn periodically for several years to control woody seedlings.

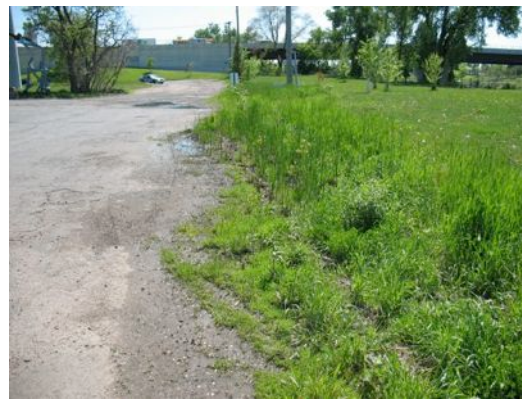
Photo 15. Boundary of parking lot and park; stormwater runoff pools here—note the darker gray water stains. Opportunity for infiltration.

**RECOMMENDATION:** Perhaps make a raingarden to catch the runoff at the bottom of the parking lot. Grading created a fairly high berm at the edge of the park which blocks runoff from entering infiltration areas. Currently, runoff has nowhere to spread out and infiltrate. If possible, remove a strip of the paved parking lot for an extension of pervious surface. Communicate with the MPRB and the Watershed District regarding this.

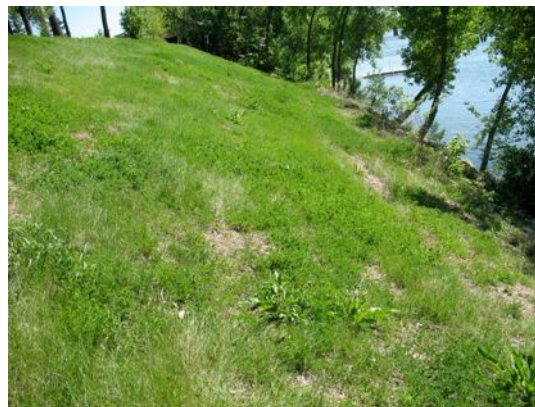
Photo 16. Moderately steep riverbank slope. Vegetation dominated by crown vetch and non-native cool season grasses. Planting native shrubs is recommended here.

**RECOMMENDATION:** Perhaps build a couple of raingardens or bio-infiltration swales. Remove curb to allow stormwater to flow into infiltration areas. There were many missed opportunities for infiltration at this park. Park design evidently did not consider stormwater runoff capture. Plant native shrubs on the bank slope and willow stakes into the riprapped toe.

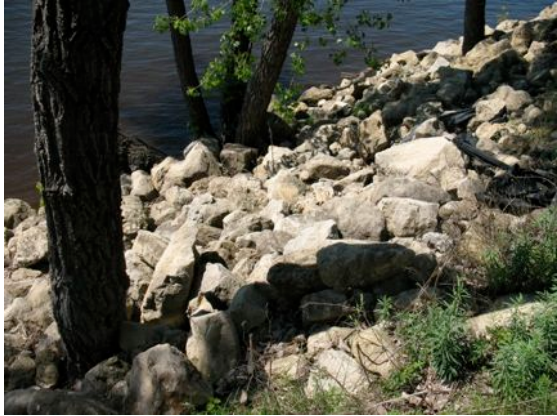
The riverbank was considerably riprapped at the toe (Photo 17),

Photo 17. Heavily riprapped toe of riverbank. Little to no vegetation currently exists. Could try planting willow stakes into riprap.

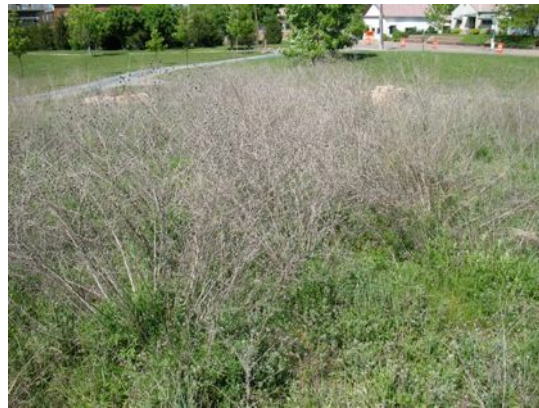
Photo 18. Restored prairie at Edgewater Park. Note the large patch of spotted knapweed that has invaded and become established (the gray, tall vegetation in the center of photo).

**RECOMMENDATION:** Release Knapweed beetles as soon as possible. Pull/treat the knapweed and the Russian sage. Remove the mountain ash tree. Burn the prairie. Re-seed/Inter-seed following burns into the black/burned areas; plant plugs into the open areas. Communicate with MPRB and FMR on the details of coordination.

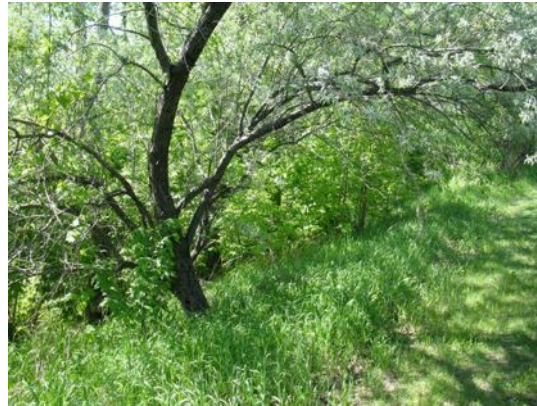
Photo 19. Marshall Terrace Park riverbank. Note the exotics: Russian olive, Tartarian honeysuckle, smooth brome grass.

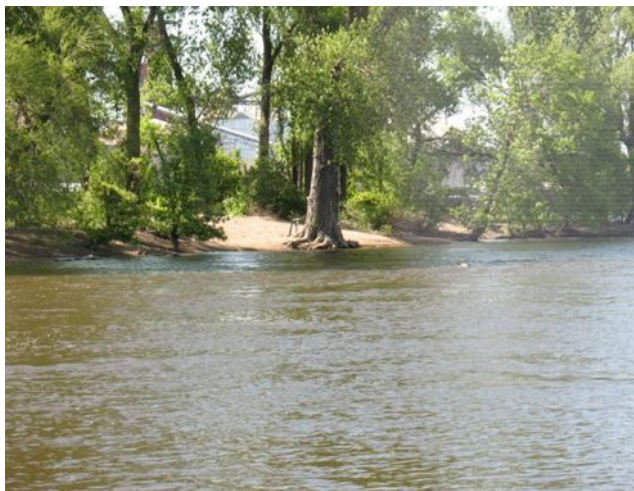
The two islands were undergoing some pretty severe and steady erosion. At each islands' leeward end, cottonwood trees had fallen into the water. Also, there was mostly bare soil on the banks, and abundant bare soil on the uplands, too (Photo

Photo 21. Close up of eroding heron rookery island. Note the large areas of bare soil and prominent bare roots of the large nesting tree on the island's shore.

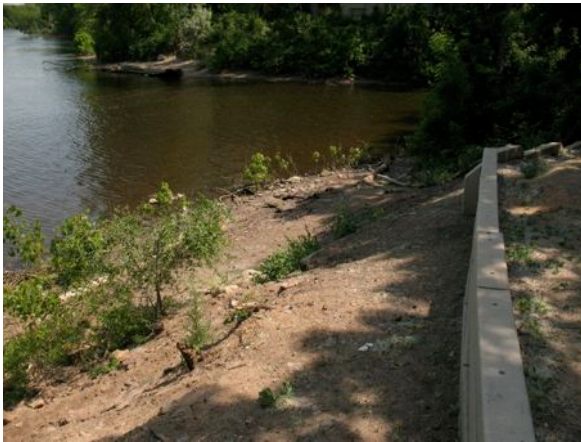
Photo 22. "North Corner" of Bassett Creek confluence with the Mississippi River. Note the extensive bare and loose soil near the wall. Also note the wide bare soil shores on each "corner" of the mouth of the creek, indicating that significant erosive forces must be at work here.

The "corners" of the river shoreline, where the Mississippi meets with Bassett Creek were in poor condition, especially the northern one (Photo 22). The northern corner had very little established vegetation, and almost 95% exposed, bare soil, which was rapidly eroding. The south corner was not eroding too much, but did have many invasive species that had invaded.

**RECOMMENDATION:** Remove large, exotic shrubs and replace with a diversity of native shrubs. Stabilize the north corner with both hard and soft armoring

practices. Perhaps consider installing rock vanes to direct the thalweg to the middle of the channel. Plant cottonwoods.

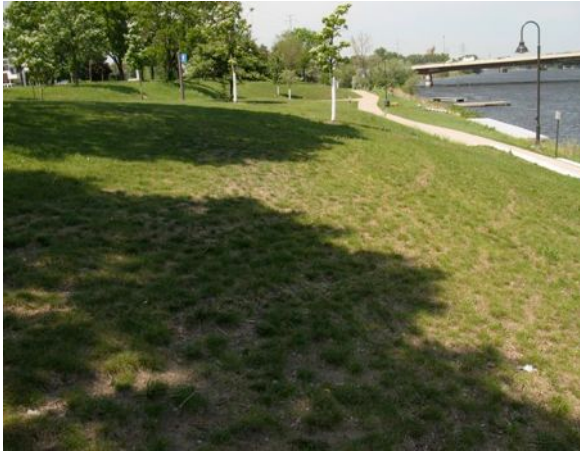
Photo 23. Broad expanse of turf that would be a good site for a raingarden or native landscape.

Although there are there are plans that call for a raingarden in this area, not yet existed at the time of the survey (Photo 23). There was a very nice shoreline restoration, though, located on the riverside of the walk and on the slope/bank of the river (Photo 24). Between the sidewalk and the upper areas (sloped), was currently being maintained in mowed turf-grass, which is a lost opportunity for infiltration (Photo 25).

**RECOMMENDATION:** Install a large, broad, shallow raingarden or perhaps a native prairie garden, on the upper side of the walkway, to capture stormwater runoff. Between 17<sup>th</sup> Avenue North and

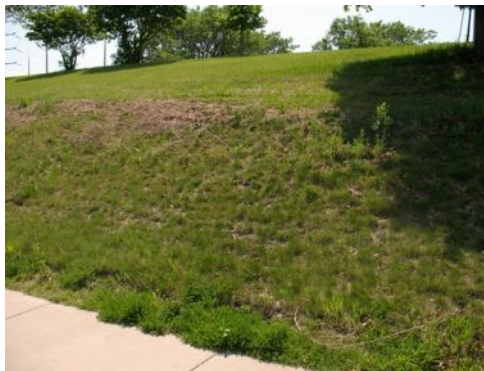
Photo 25. Candidate slope for native landscape or no-mow turf. Probably no need to continue mowing this slope.

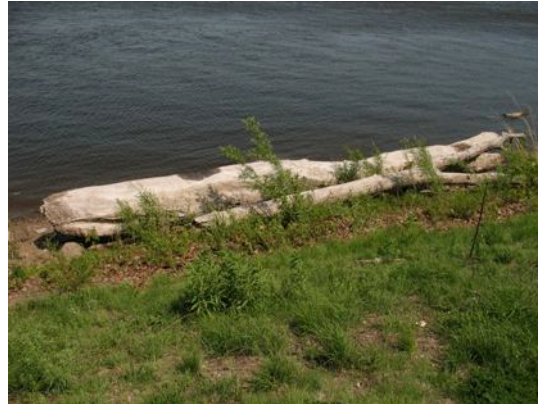
Photo 26. Existing logs can serve as good wavebreaks for new shoreline plantings. Anchoring them with cables is recommended, though.

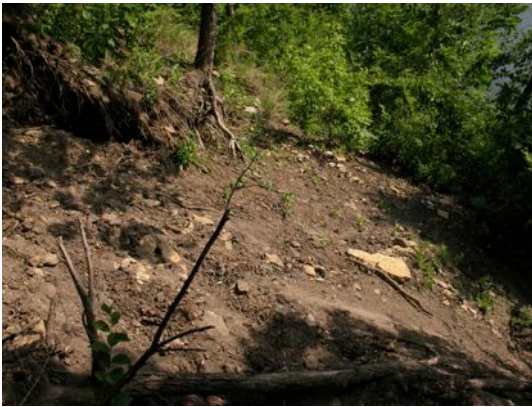
rock, stone, and slag-type debris on the slope, adding to the degradation and making footing treacherous (Photo 28).

Photo 28. North tip of Nicollet Island. Note the large area of bare soil, exposed roots, and active erosion. Also note the loose rock.

**RECOMMENDATION:** Stabilize the soil on the banks of this northern tip of the island. First re-contour as necessary. Then install water bars, erosion control fabric, check dams, etc., to absorb energy of water runoff. Volunteers could hand-pull buckthorn and honeysuckle seedlings. A professional crew could cut larger ones and treat the stumps. Then plant and/or seed with a diversity of native graminoids and forbs. In time, a matrix will be formed of

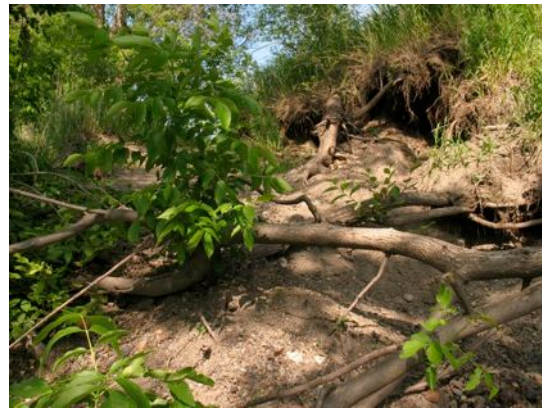
Photo 29. Another shot of the erosion at the north tip of the island. Note the extensive amount of bare roots. Also note the mantle of grass holding onto soil at the top of the photo.

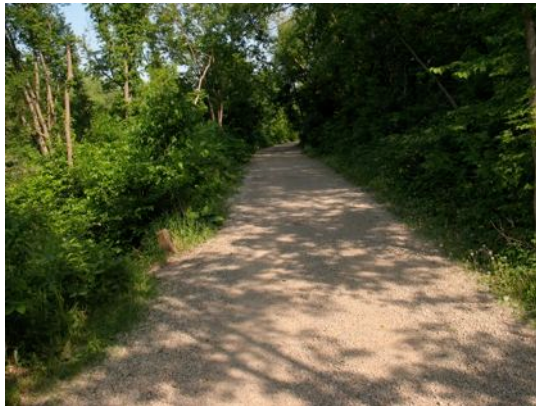
Photo 32. Foot trail on northeast bank of Nicollet Island, east of Bridge to B F Nelson Park. Garlic mustard has invaded this area.

a fire was found, as well as a couple of beer cans. The shoreline here had a couple of very large slabs of cement. A narrow footpath (Photo 32) traversed the entire northern bank, skirted in front of the cave, and ended at the BF Nelson Bridge.

Once established, this site should be monitored annually for invasive exotics like garlic mustard, buckthorn, and Tartarian honeysuckle. Volunteers from the neighborhood could be engaged to perform yearly monitoring. If invasives are found, they should be promptly hand pulled or spot treated.

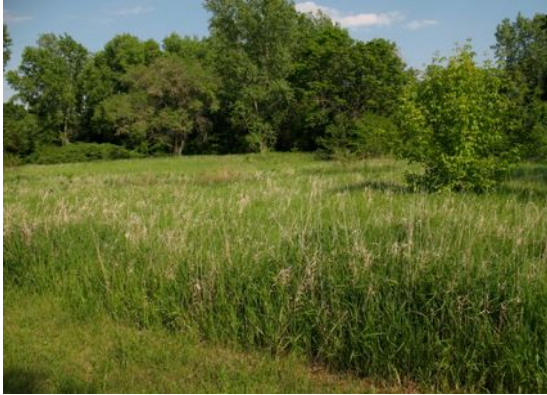
Photo 34. Old field on upland flat. Field is dominated by smooth brome grass and could be readily restored to native prairie.

**RECOMMENDATION:** Restore the open brome field (0.7 acres) to native prairie and the wooded portion (0.9 acres) to oak savanna. Only do this, though, if there is a commitment to managing it

properly, which means burning it periodically, spot treating, spot seeding, inter-seeding if necessary, and monitoring. If not, then we do not recommend restoration, since it will likely fail. If restored, though, this would be a nice addition of habitat and it would add to the beauty of the island. It also is located close to the north bank and channel area of the island, and would thus enhance the restoration those areas also.

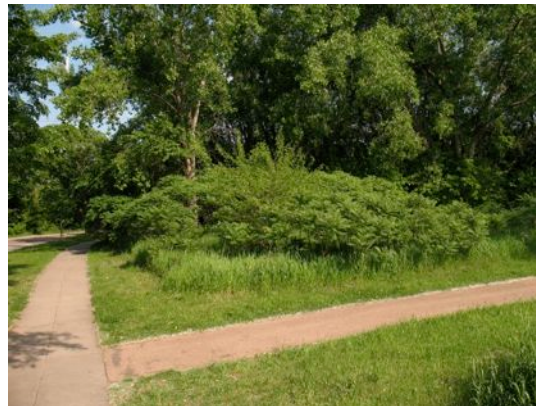
Photo 35. Woodlot that is located adjacent to the south of the brome field. Perhaps this could be restored to oak savanna.

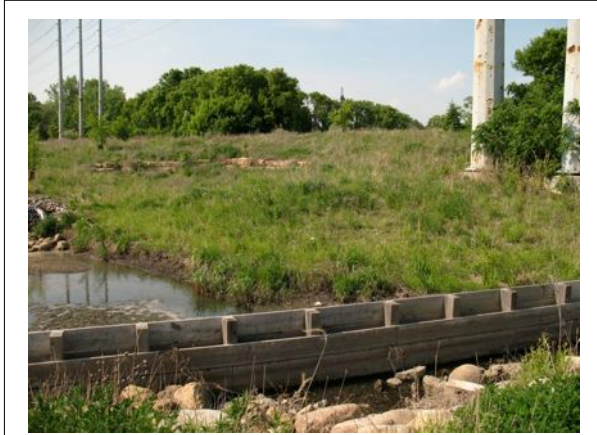
There was a nice little prairie restoration here (Photo 36). Present were blue vervain, Indian grass, bergamot, wild rye, little bluestem, milk vetch, coneflower, etc.

This prairie would benefit from an addition of more early-flowering species, which would provide food for early pollinators and visual interest for park visitors in the spring. Black alders were planted here—an interesting selection. The head of a small gully was eroding, and could be stabilized. There was nice use of sandstone slabs for a retaining wall (Photo 36). Near the retaining wall was an area of abundant exotic plants, dominated by spotted knapweed. Upland from the retaining wall was found a newly installed parkland area with turf and scattered planted trees, including Kentucky Coffeetree. Nice tree selection, but perhaps a no-mow turf

**RECOMMENDATION:** Spot treat spotted knapweed and other exotics in the restored prairie. Burn the prairie periodically (every 2-5 years) to control woody seedlings and promote prairie species.

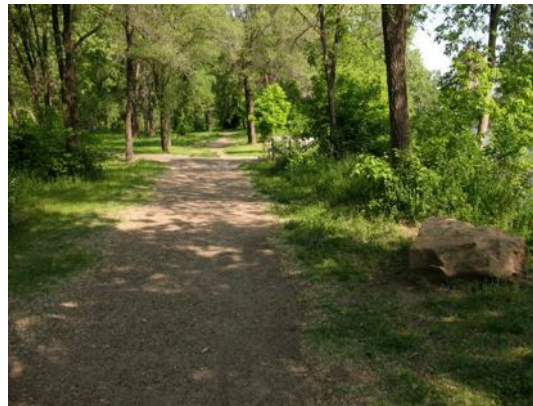
Photo 37. B.F. Nelson park, looking southeast. Channel is on the right. Riverbank stabilization has occurred, but improvements to the plant community could be made. All of the trees in the photo are Siberian elm. Weeds dominate the banks (not shown here).

**RECOMMENDATION:** pull garlic mustard. Spot treat other herbaceous weeds. Replant with native plugs and
