Willow Brook

Natural Resource Management Plan

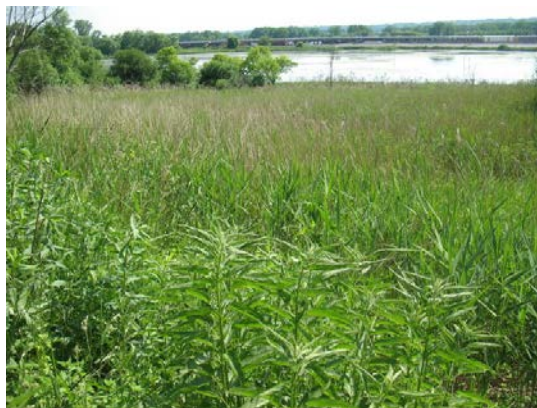
Photo 8. View of Little Pigs Eye lake in the distance, with sedge meadow in the foreground.

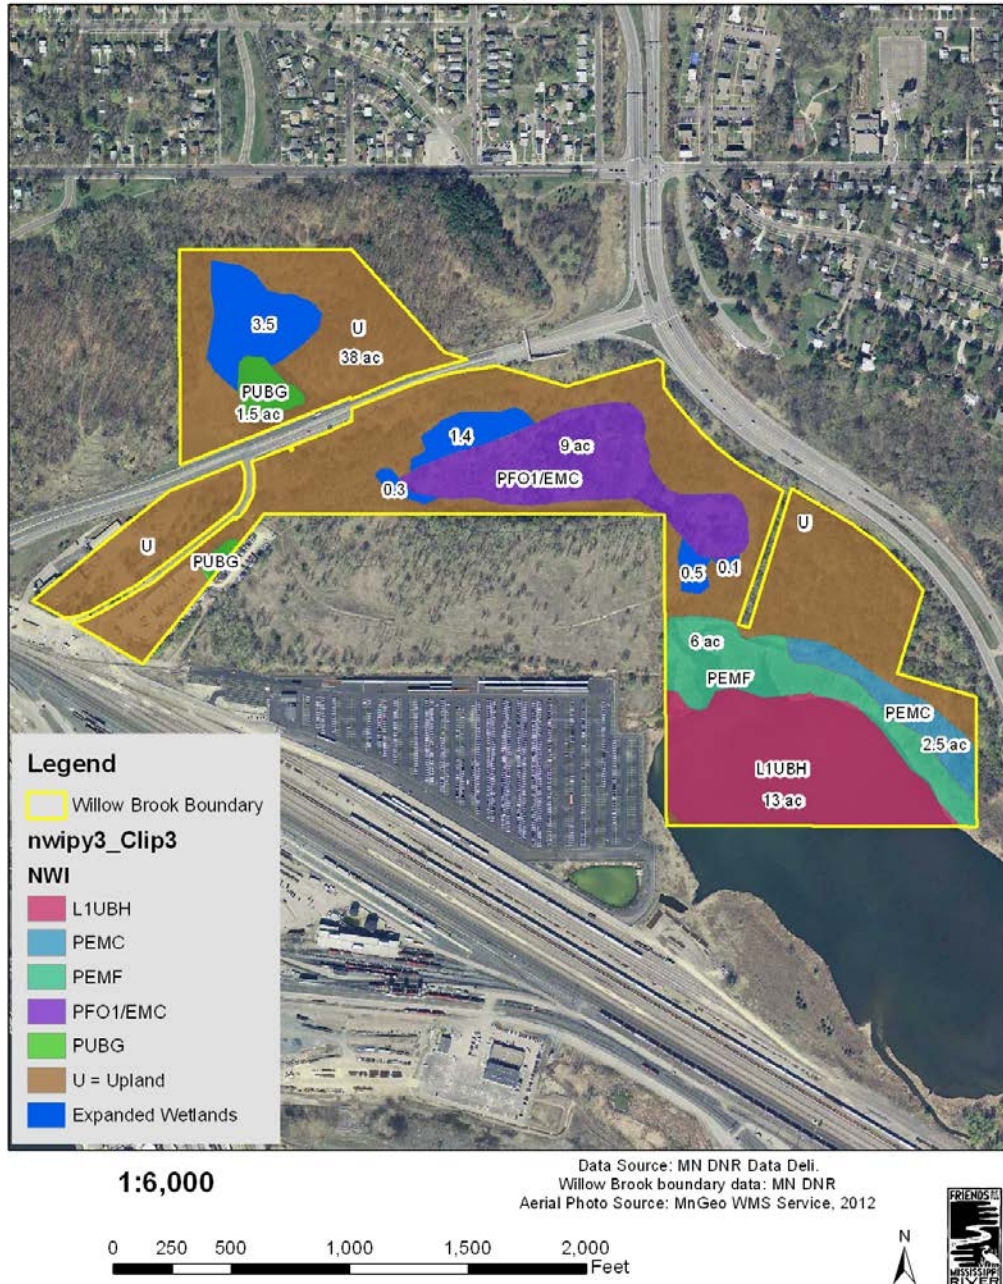
Figure 13. National Wetland Inventory map with expanded wetland areas (inserted by FMR Ecologist) in blue.

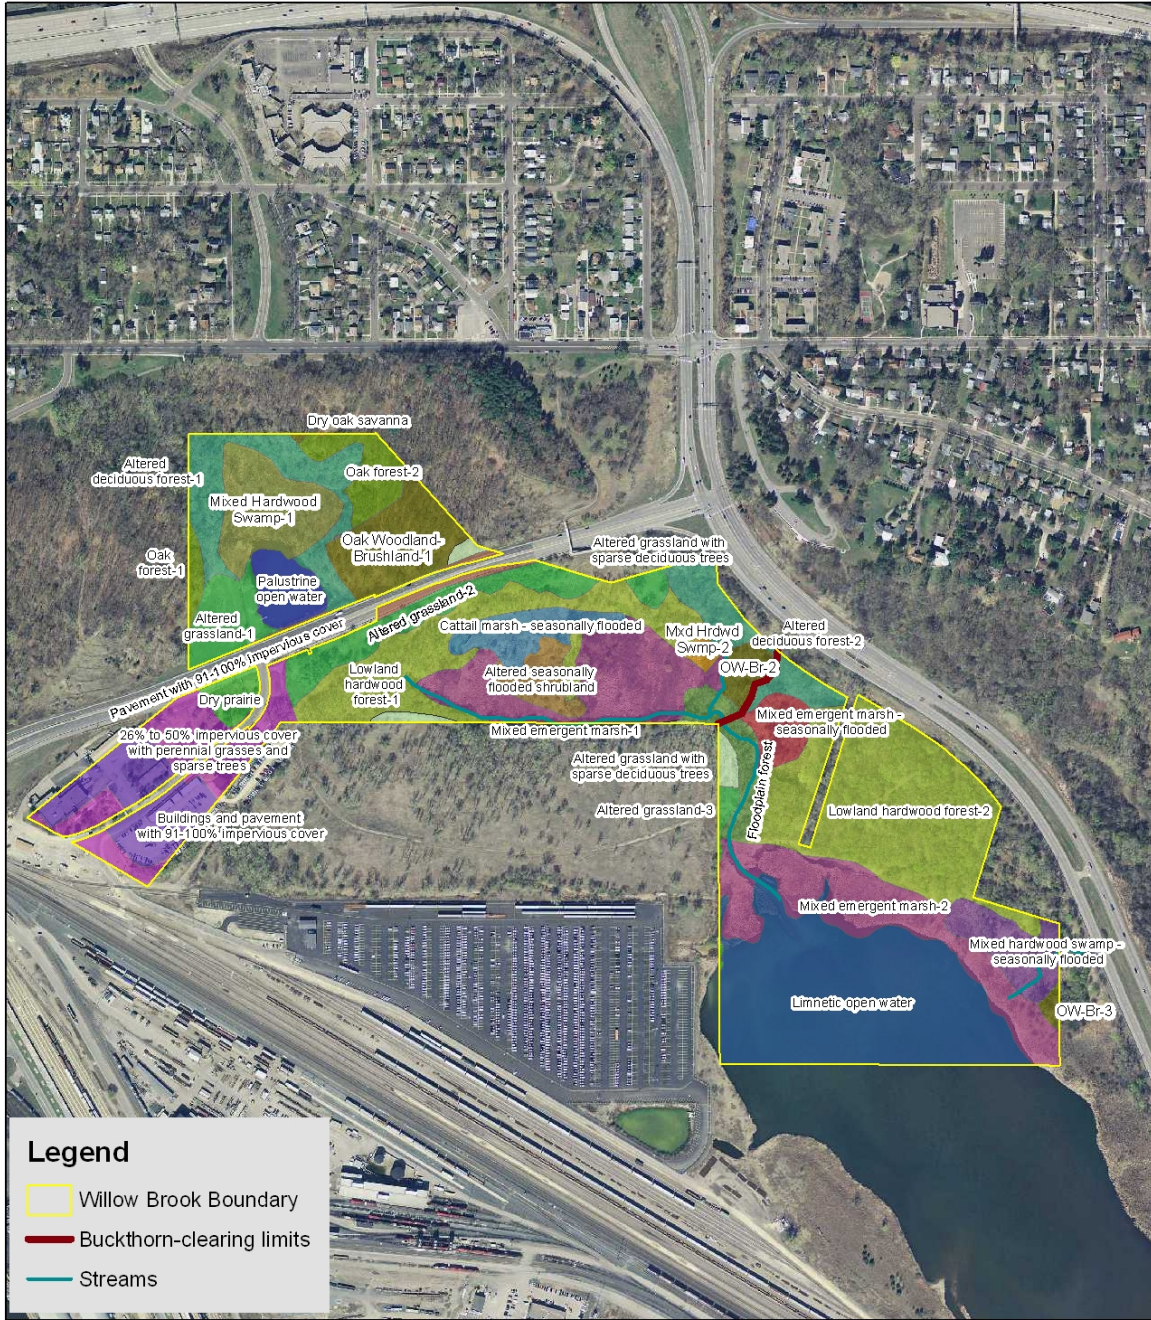
Lowland hardwood forest (LHF) occupied a large portion of the middle and southern parts of the property. One of the LHF units (LHF-2) covered the former dump site. The LHF units were heavily infested with garlic mustard. Oak forest and woodland (that had been recently cleared of exotic woody brush) occupied the area north of the seepage swamp on the north side of the property near the fish hatchery pond. On the south side of the property there was a remnant oak woodland (formerly savanna). A single, very old bur oak tree was found at the extreme southeast corner of the property, surrounded by buckthorn forest and then by wet prairie/seepage meadow wetlands, some of which were high quality.

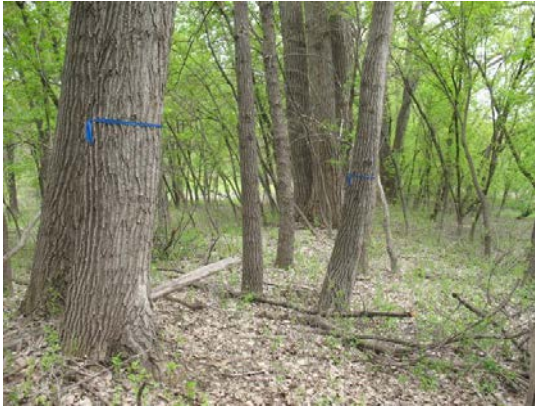
Photo 9. View of LHF-1.

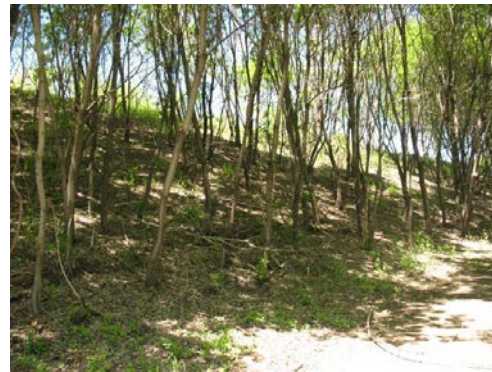
Photo 10. Grove of young boxelder on Warner Road berm.

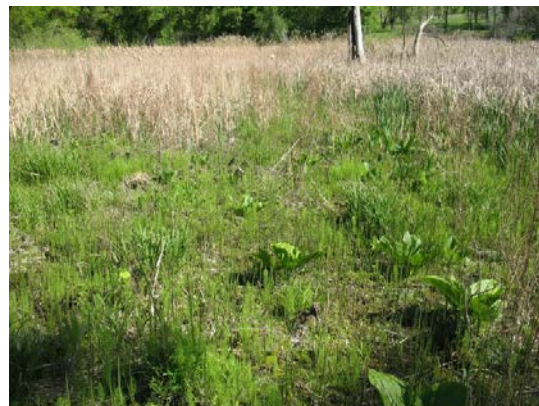
Photo 14. In the foreground, an area where buckthorn was recently cleared. Compare the difference in vegetation to that of the cattail clone in the background. Cattails are starting to invade into the foreground of the photo.

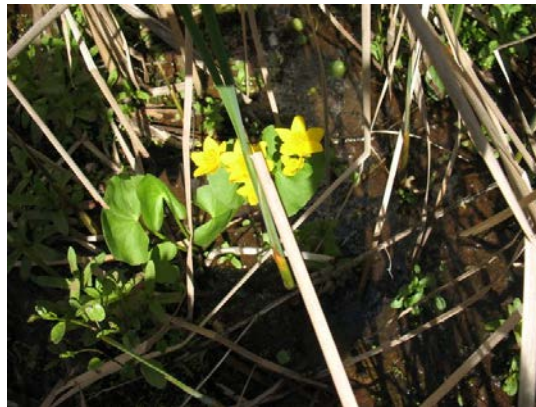
Photo 13. A marsh marigold plant surviving beneath a canopy of hybrid cattails in the Cattail Marsh.

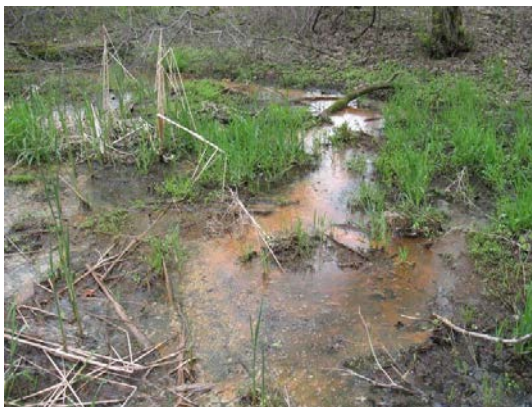
Photo 14. Rusty-brown substance in seep source area, at western end of Cattail Marsh.

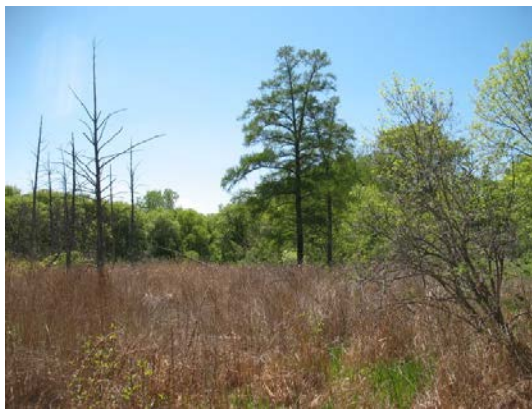
Photo 16. Tamaracks, living and dead, in "southern population".

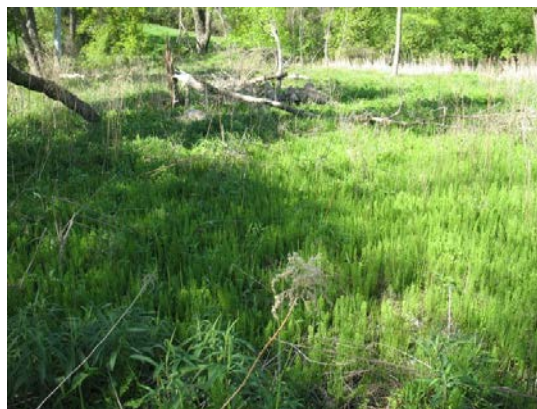
Photo 17. Field of *Equisetum palustre* on upland margin of marsh.

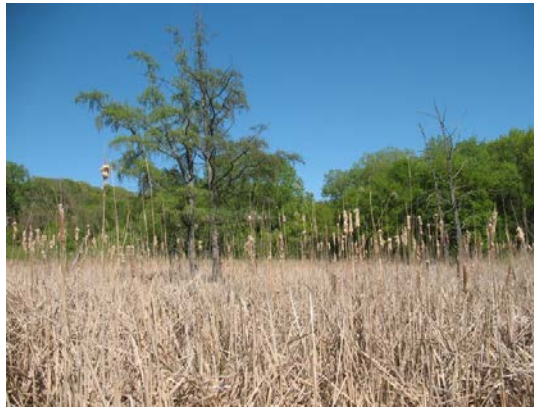
Photo 18. Mixed Emergent Marsh-1, view looking eastward.

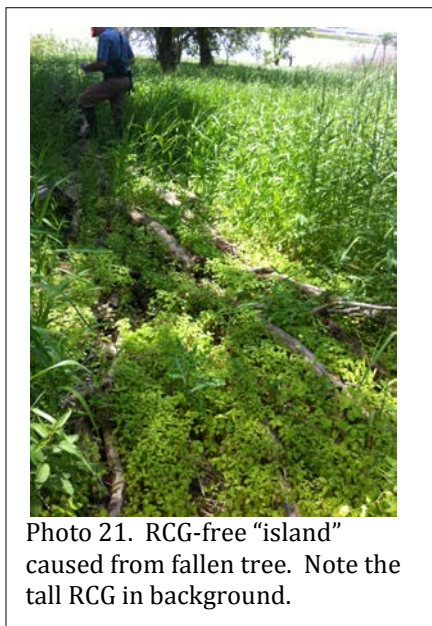
Photo 21. RCG-free "island" caused from fallen tree. Note the tall RCG in background.

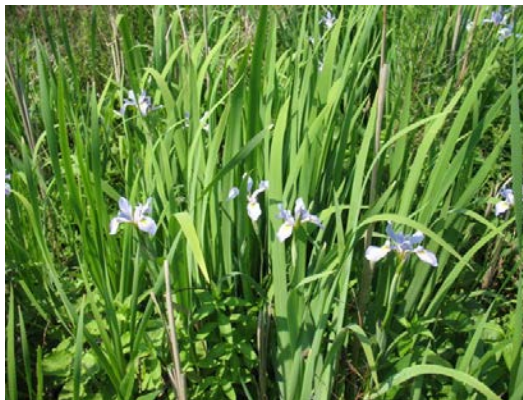
Photo 24. Blueflag iris and broad-leaved cattail in sedge/seepage meadow on adjacent property owned by City of St. Paul.

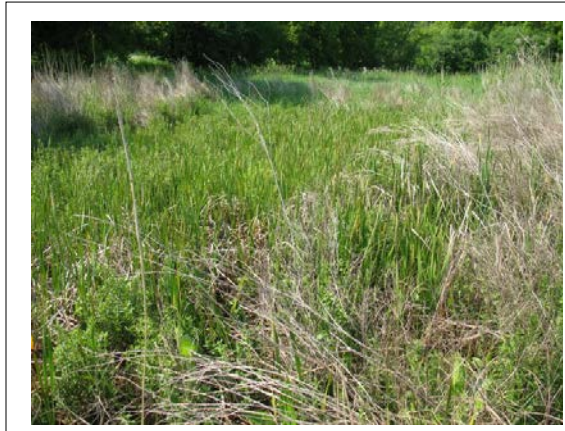
Photo 25. Illustrates the contrast between "grass meadows" on right and "sedge meadows" on left.

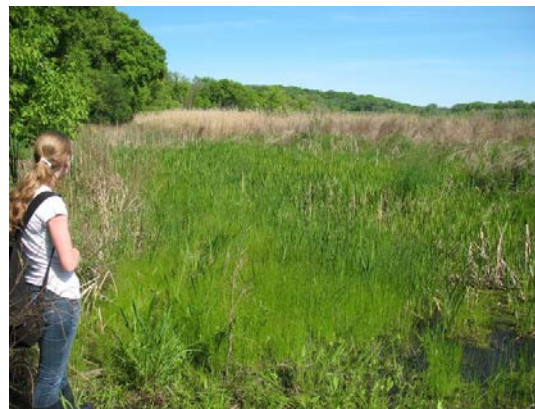
Photo 26. FMR Intern standing near a sedge meadow located where LHF-2 borders Mxd-Em-Marsh-2. The sedge meadow is green and the *Phragmites* grass is straw-colored.

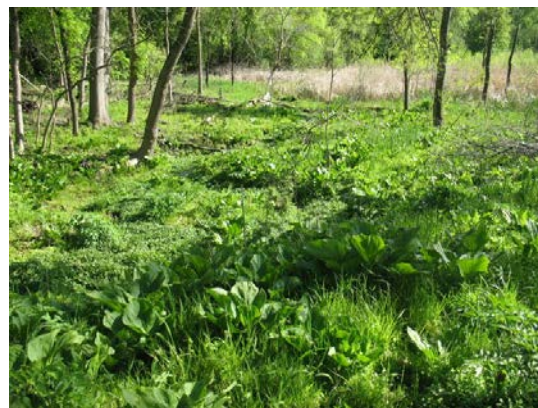
Photo 31. Mx-Hrd-Swmp-2. View looking southward.

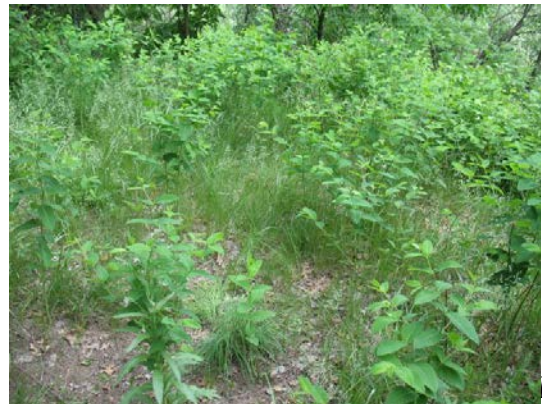
Photo 37. Dry prairie opening in OW-Br-1.

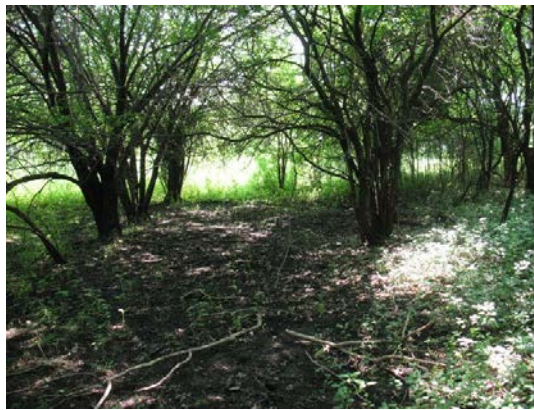
Photo 40. "Old-growth" buckthorn in OW-Br-3 unit. Note the very dark understory with almost no vegetation on the ground. The remnant wet prairie community is in the background.

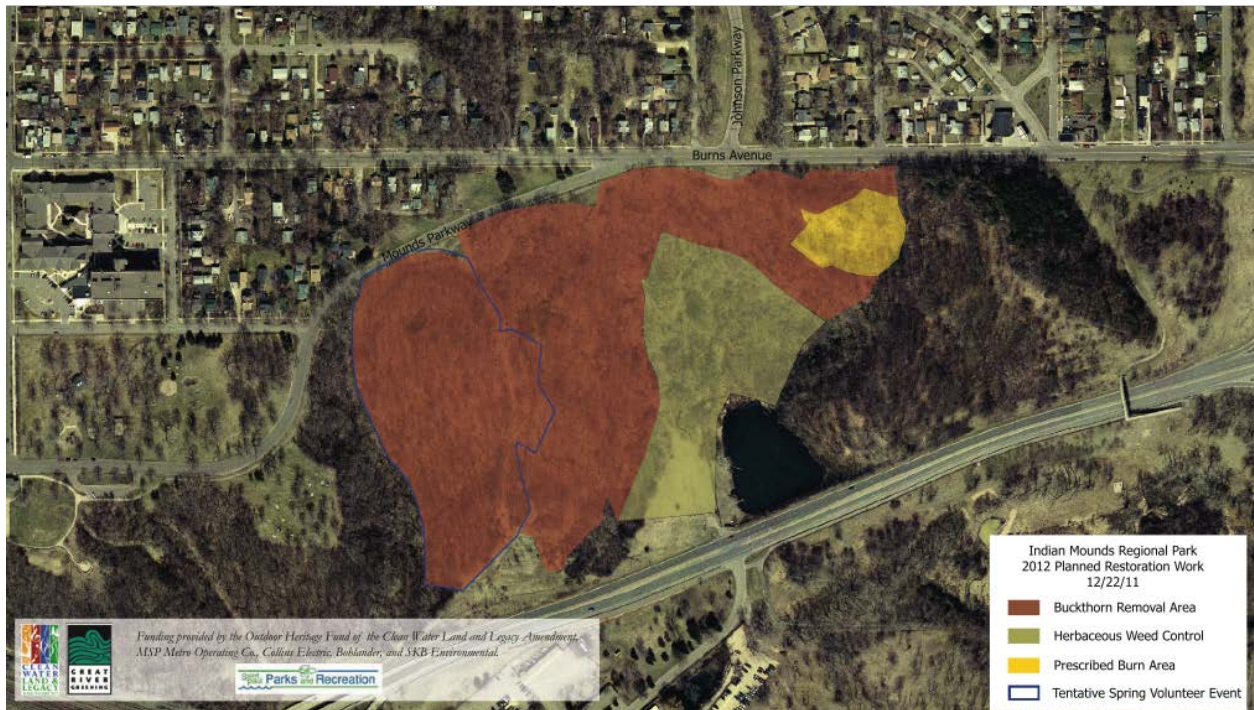
Planned Restoration Work at Mounds Park in Land Adjacent to Willow Brook Hatchery Pond
