# Above The Falls: Natural Areas Scoping

Friends of the Mississippi River  
360 North Robert Street, Suite 400  
St. Paul, MN 55101  
Ph: 651-222-2193 x33  
December, 2012

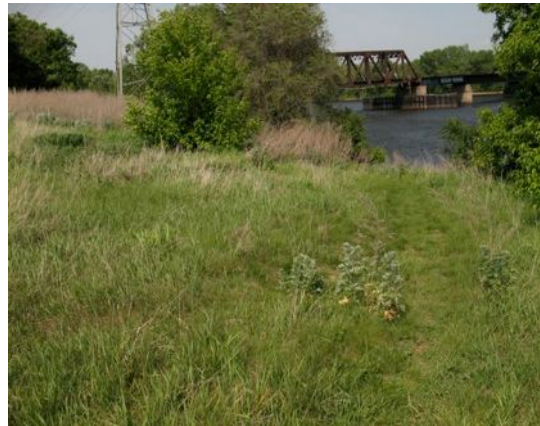
This park was bounded by railroad tracks to north, the Mississippi River to east, street and condominiums to west; it grades into the 22<sup>nd</sup> Ave Raingarden to the south. Relief was moderate—a steeper slope exists on the north end of the site, by the river. It appeared that rubble and debris had been dumped on and pushed over the bank here. There existed a plant community typical of highly disturbed sites, on the slope, dominated by exotic plants. A pylon was located at base of slope, on a river terrace near a sandy beach (Photo 6). A small foot trail wound its way up and down the slope, from the beach area to the ridge top (Photo 5). Several cottonwoods, a few silver maples and willows lined the upper beach area. Many Siberian elms have become established

Photo 5. Flat ridge top of riverbank, looking northward towards Railroad Bridge.

**RECOMMENDATION:** Although disturbed, this area has the potential to be restored to a diversity of habitats. We recommend removing all Siberian elms on the slope and the grasslands, leave the boxelder, and then plant bur oaks to eventually replace them and the Siberian elms (Photo 7). We also recommend controlling the non-native herbaceous plant species and performing controlled burns on the property in general. Fire would control Sib elm seedlings and other woody plants on this site. Spotted Knapweed would have to be hand-pulled and spot treated with chemicals. We also recommend stabilizing the steep upper bank.

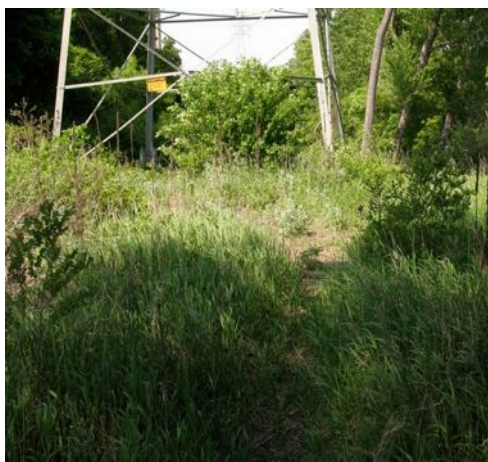
Photo 6. River terrace at base of pylon.

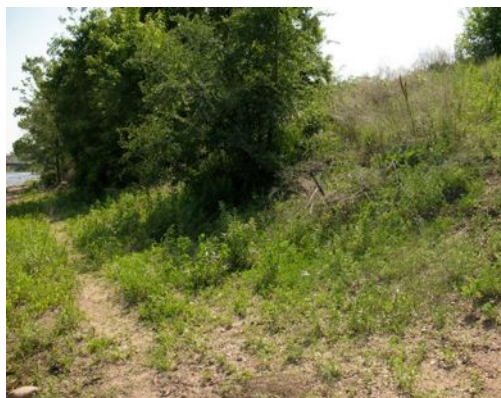
Photo 7. View of long, upper riverbank, looking southward.

exotics and aggressive natives: spotted knapweed, garlic mustard, common burdock, Russian sage, Canada thistle, ground ivy, smooth brome, evening primrose, grapevine, Canada goldenrod, giant goldenrod, and red clover. A large (10' x 5') metal structure was found lying in the grass at the top of the ridge. There was a gully that has eroded its way onto the slope, on the south end of the upper bank. The slope gets shallower as one moves towards the south.

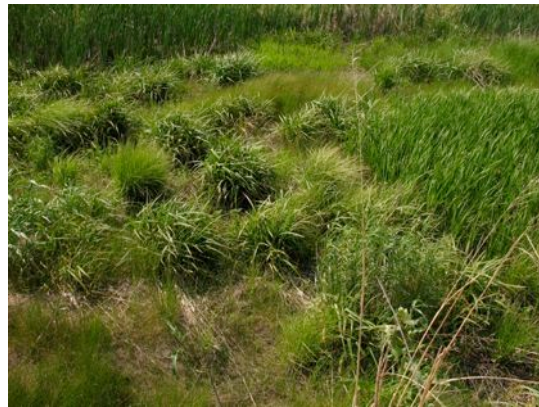
This raingarden was located outside of the Minneapolis Park and Recreation Board (MPRB) building, in a depression of the ground, between a cement sidewalk and the MPRB parking lot. During the site visit, this raingarden looked good, with many native species flourishing here (Photo 13). There were patches of non-native plants and several scattered Siberian elm seedlings present here also.

Photo 13. Center of the 22<sup>nd</sup> Ave Raingarden. Note the nice mix of sedges, rushes, and grasses.

**RECOMMENDATION:** We recommend that the raingarden be burned. Burning would control the woody seedlings that are volunteering into the infiltration basin. Burning should be done either in the spring or the fall. Hybrid cattails could also be controlled—by hand wicking with an aquatic herbicide mixed with a non-ionic surfactant.

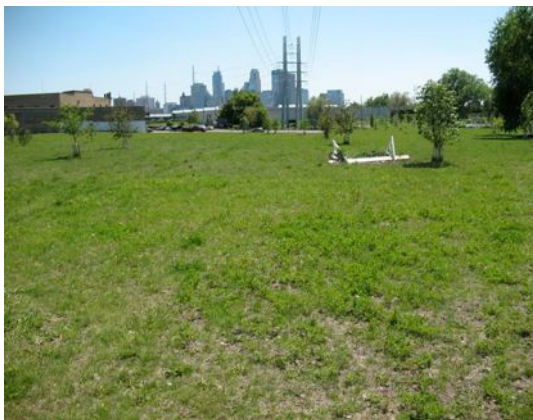
Photo 14. View of Sheridan Park, looking south.

complex, which has recently been turned into a City park. Soil was very compact here. It had been recently seeded to turf grass and planted with scattered trees or groups/rows of trees: hawthorn, crab apple, pines, maples, cottonwoods, etc. The terrain was very flat and level (Photo 14). Pylons and high power lines towered over the park. The site was located between a railroad track (to east) and the river (to west). Across the river was Ole Olson Park. This site was also north of the old Grain Belt “Case Beer Warehouse.” A foot trail continued on the north side of park, to a railroad bridge and beyond. Apartments, Dog Daycare, and other businesses are located adjacent to this trail to the east. The railroad tracks appeared to be abandoned. Nearby, a homeless occupation site was observed.

**RECCOMENDATION:** The rest of the field could be potentially restored to prairie, which would act as a significant buffer for the river. Perhaps the best use for this site, though, is to continue its present usage. There may be plans for a potential war memorial or monument for this site, however. If so, incorporating native plantings and infiltration areas would be recommended, as opposed to a full-blown prairie restoration.

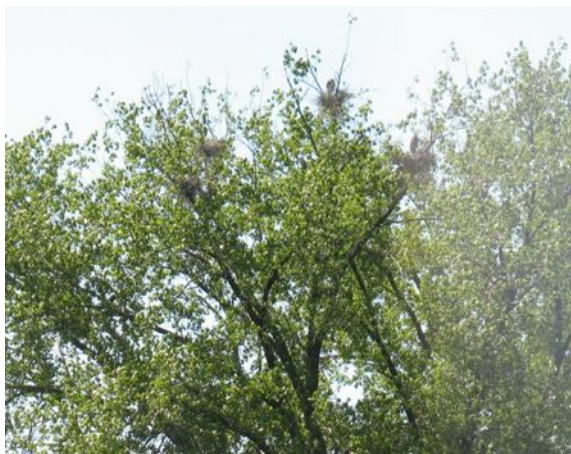
Photo 20. View of heron nests in tops of large cottonwood trees on an island across from the park and from Xcel Energy. Note that some of the nests are occupied by birds.

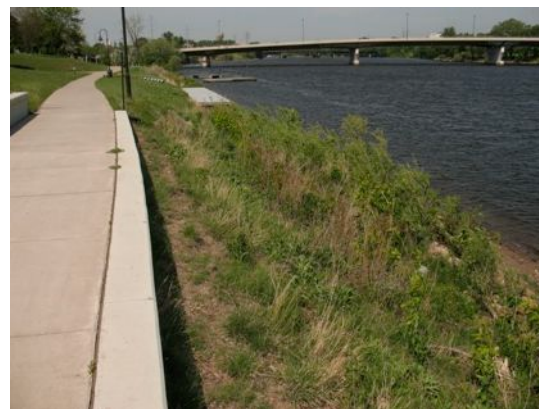
Although there are there are plans that call for a raingarden in this area, not yet existed at the time of the survey (Photo 23). There was a very nice shoreline restoration, though, located on the riverside of the walk and on the slope/bank of the river (Photo 24). Between the sidewalk and the upper areas (sloped), was currently being maintained in mowed turf-grass, which is a lost opportunity for infiltration (Photo 25).

Photo 24. Riverbank restored to prairie.

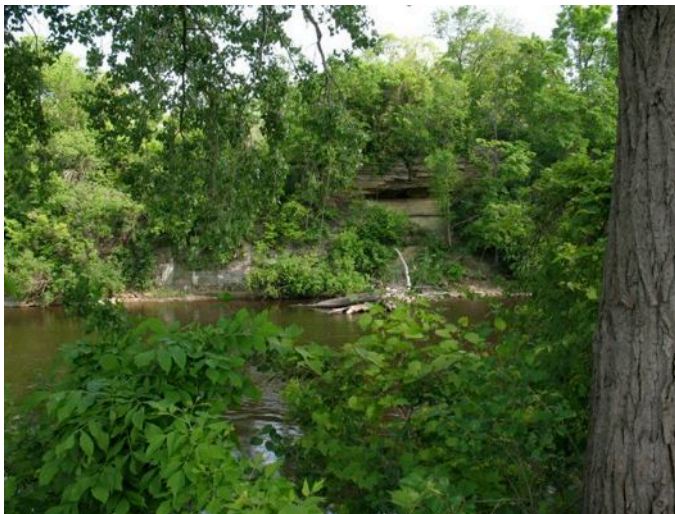
Photo 27. View of the north shore of Nicollet Island from across the channel.

The north end and the channel areas of Nicollet Island (Photo 27) represent very good opportunities for restoration. The bank on the far north end of the island was very high, and quite steep. It was highly disturbed. There were large areas of bare soil (Photos 28, 29). At one time some steps must have been constructed here, as evidenced by scattered pieces of treated railroad ties and the remnants of a steps at the bottom of the bank. It appeared that this was at one time a landing, but that it has long since

**RECOMMENDATION:** Stabilize the soil on the banks of this northern tip of the island. First re-contour as necessary. Then install water bars, erosion control fabric, check dams, etc., to absorb energy of water runoff. Volunteers could hand-pull buckthorn and honeysuckle seedlings. A professional crew could cut larger ones and treat the stumps. Then plant and/or seed with a diversity of native graminoids and forbs. In time, a matrix will be formed of

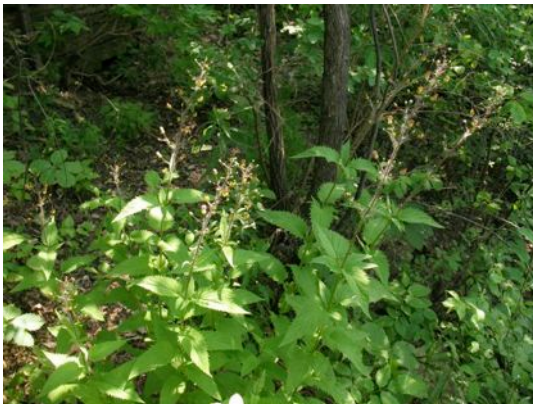
Photo 30. Figworts in bloom on a flat shelf located on the channel side of the island. These were growing near the base of a large cottonwood tree.

low in diversity, still had a few native forbs including zigzag goldenrod, clearweed, Virginia creeper, heart-leaved aster, and figwort (Photo 30). Prickly ash became abundant near the cave and then beyond to the bridge—it's presence indicates that a more open woodland community most likely existed here at one time. A couple of very large cottonwoods persisted at the low bank on the channel side, which helped stabilize the slope there. Near the base of one of these old giants, near the foot bridge to B.F. Nelson Park, there was a small, flat shelf of land that contained many native forbs, as well as morel mushrooms.

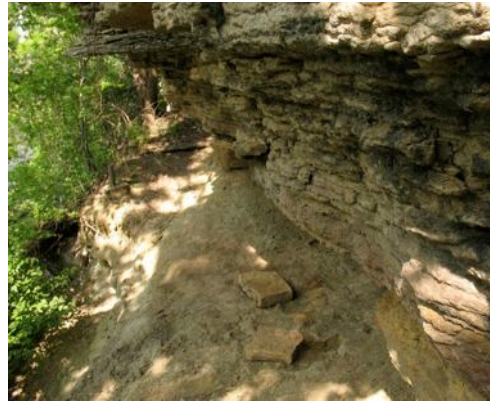
Photo 31. Bedrock outcrop with small cave.

There was a small cave in a bedrock outcrop of sedimentary limestone on the north side of the Island (Photo 31). People must frequent this spot, since the remnants of

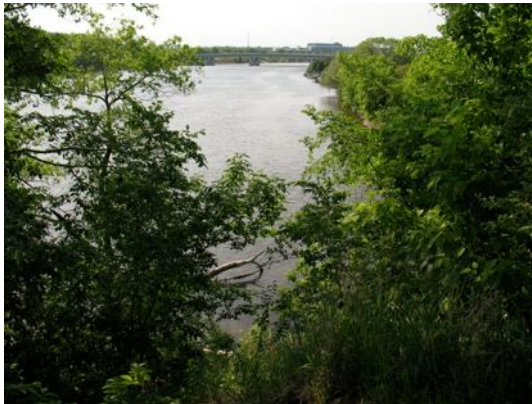
Photo 33. Vista upstream the Mississippi River from the north end of Nicollet Island. Boom Island is on the right side shoreline of this photo.

To be noted are the spectacular views from the northern part of the island (Photo 33) , as well as from the channel side. If the bank were to be restored, the views would be an important part of the aesthetic quality of the project.

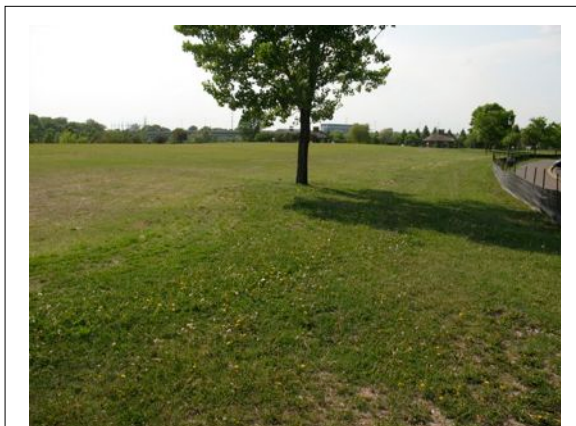
This park was dominated by vast expanses of turf grass (Photo 38). At the time of this field survey, there were large areas of new sod. At a time when the trend is to reduce turf not to increase it, this park seems out of sorts. Perhaps ball fields are planned for the site? The shoreline buffer is rather thin and narrow, with some exposed bedrock. Scattered large cottonwoods abound—basically, the same plant community as on the Island, with the addition of grey dogwood. Seemingly, more erosion was happening on this shoreline as compared to the island, but that was because the water, being closer to the observer, gave a false impression of increased erosion.

Photo 38. Traditional urban park landscape of turf grass and scattered ornamental or shade trees.

**RECOMMENDATION:** No restoration recommended here.
